Keiju Medical Center "The Miracle of Noto"

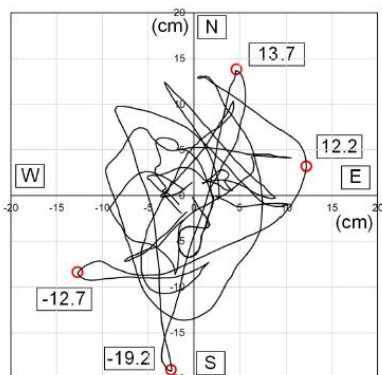
Figure 1 Trace of the displacement

Figure 1 shows the trace of the displacement caused by the Noto Peninsula earthquake, with a maximum displacement of 192 mm, about half the expected displacement of L2 earthquake.

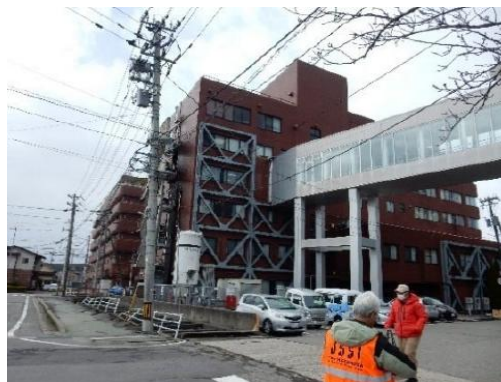
Photo 3: 3rd Ward (foreground) and 5th Ward (back)

On the other hand, photo 3 shows 3rd Ward, which is about 45 years old and has outdated earthquake resistance, and has already been reinforced to withstand earthquakes, while 5th Ward was completed in 2000 and is earthquake-resistant.

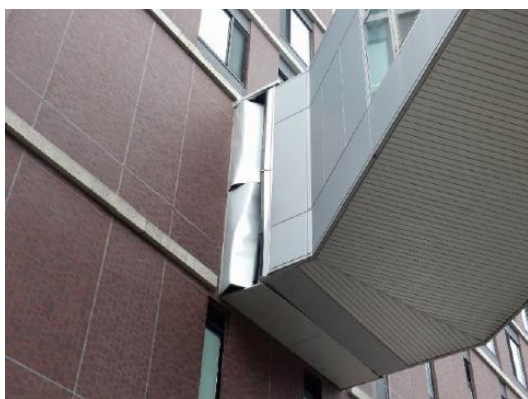
Photo 4: Damage to the SI Exp. J panel

As shown in Photo 4, damage occurred to panels in the walkway and Exp. J of the seismic isolation building, but there were no particular problems with movement.

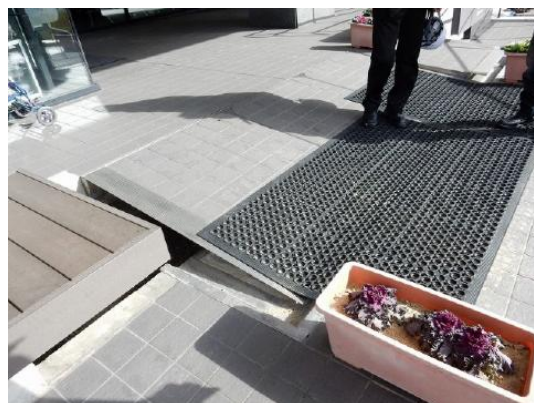
Furthermore, as shown in Photo 5, ground subsidence occurred in the exterior parts due to liquefaction, causing steps and gaps at entrances and exits.

Photo 5: Building and steps separated

connected to the main building

by ground subsidence due to liquefaction
