## Aso Medical Center

It opened in 1950 as Aso Central Hospital, and in 2014, a new hospital facility with a seismically isolated structure was completed, and it was renamed Aso Medical Center.

During the 2016 Kumamoto Earthquake, the distance to the Futagawa fault zone, the epicenter of the earthquake, was about 10 km, and the horizontal deformation of the seismic isolation layer was measured at a single amplitude of 46 cm, which is probably the largest displacement ever, and about 90 cm in both amplitudes.

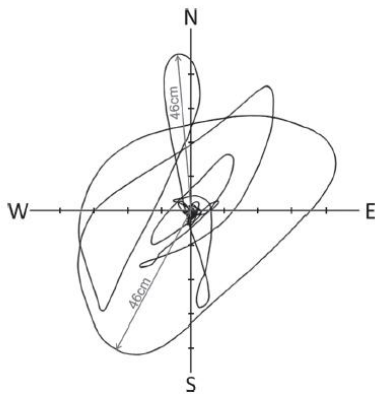
Figure 3: Record of the scratch gauge

On the other hand, the main shock at 1:25 on the 16th recorded a very large displacement of the seismic isolation layer, measuring 46 cm in single amplitude (Equivalent to about 330% strain of laminated rubber bearing with a diameter of  $\phi 700$ ). Subsequent inspections showed some cracks in the earthquake-resistant building, but no damage was found to the structure of the seismically isolated building. As for the condition of the seismic isolation material, the rubber covering the perimeter had only shifted, and the rubber itself was sound, and when the displacement history of the scribe was examined, it was found that the remaining performance was sufficient.

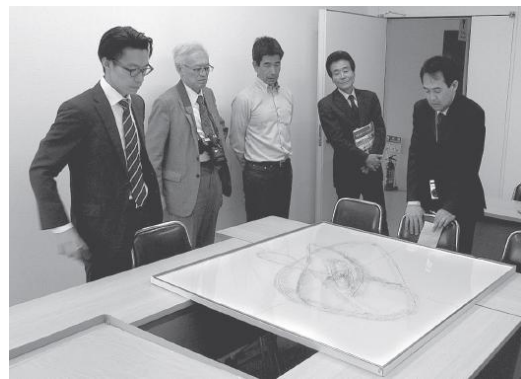
Photo 4: Explanation of the scratch marks (replica) by Hiroshi Yamamoto

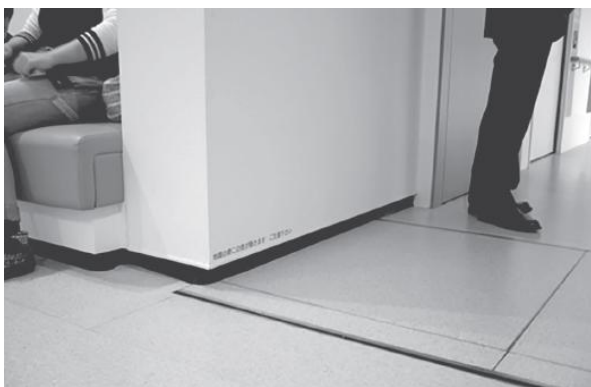
During the main earthquake, the Exp.J (photo 5) between each building came loose, and inside the seismically isolated building, lockers collapsed and items fell off the shelves (photo 6). However, since it happened in the middle of the night, some patients in the ward did not realize that the earthquake had occurred.

Photo 5: Exp.J and sleeve wall between the seismically isolated building and the seismic resistant building

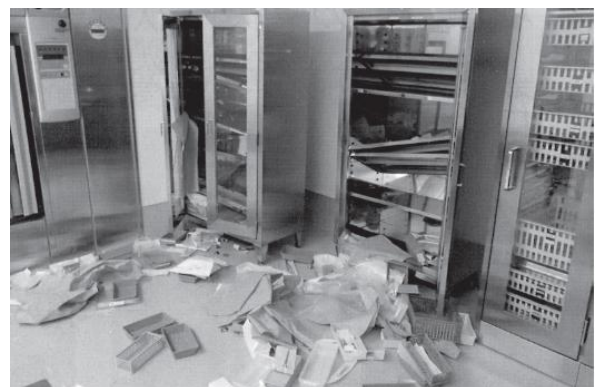
Photo 6: The situation on the second floor

A1. They knew about the seismically isolated building, but after the earthquake, they became more aware of the importance of layouts that take into account the possibility of shelves collapsing or items falling, and of fastenings. Currently, the only requirement for a disaster base hospital is that it must be of an earthquake-resistant building, but after experiencing the high seismic performance of the seismically isolated building in the Earthquake, we should actively adopt the seismically isolated building.
