Ishinomaki Red Cross Hospital:

The hospital that sparked the spread of seismically-isolated structures.

•Ishinomaki Red Cross Hospital's seismically-isolated structure allows it to function as a disaster base.

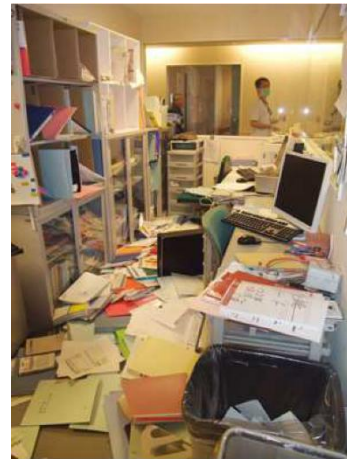
However, since it was estimated that an acceleration of about 150 gal occurred, documents on desks and documents placed on shelves without doors slid and fell to the floor, as shown in the photo. However, one was injured, and medical activities were quickly resumed by simply arranging the documents.

6th floor Situation after the quake

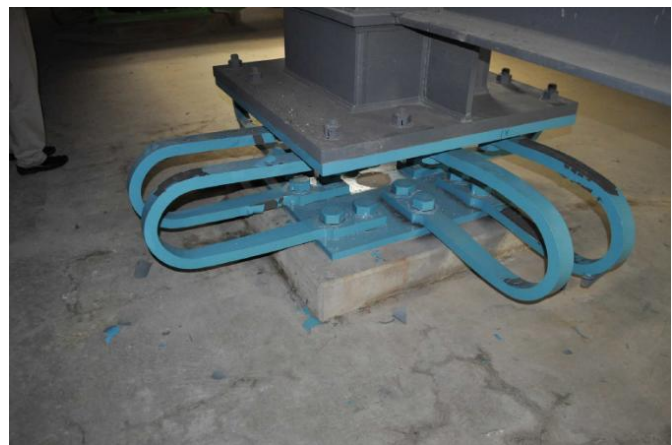
Paint peeling was observed on almost all steel dampers, and the damper mounting bolts were loose in many areas. However, given the change in shape of the dampers and the resulting peeling of paint, it was believed that they were still performing as intended. In addition, the isolators and elastic sliders only had a few peeled paint spots, and no loose bolts were found. Emergency measures such as retightening in necessary areas had been implemented, and the structure had adequately withstood the aftershocks since 3/11.

Steel damper after the quake

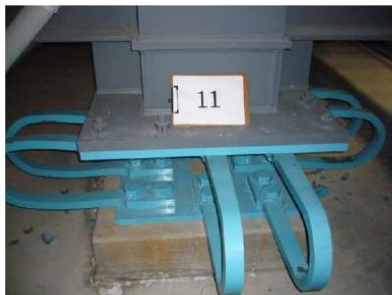
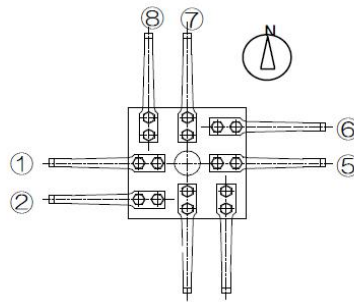
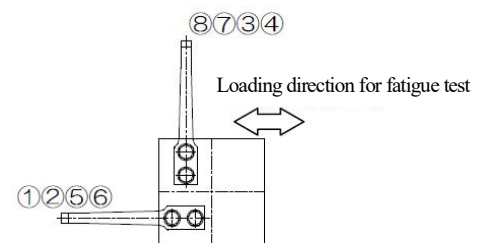
By 3/11, this hospital had already experienced two earthquakes of intensity 5 or more, and in order to check whether the heavily deformed steel damper still had sufficient energy absorption capacity, one of the eight-piece external type was removed (and replaced with a new one) and fatigue tests were conducted. Four test pieces were made, each consisting of two pieces, and the following two types of tests were conducted.

Test specimen of steel damper (removed)

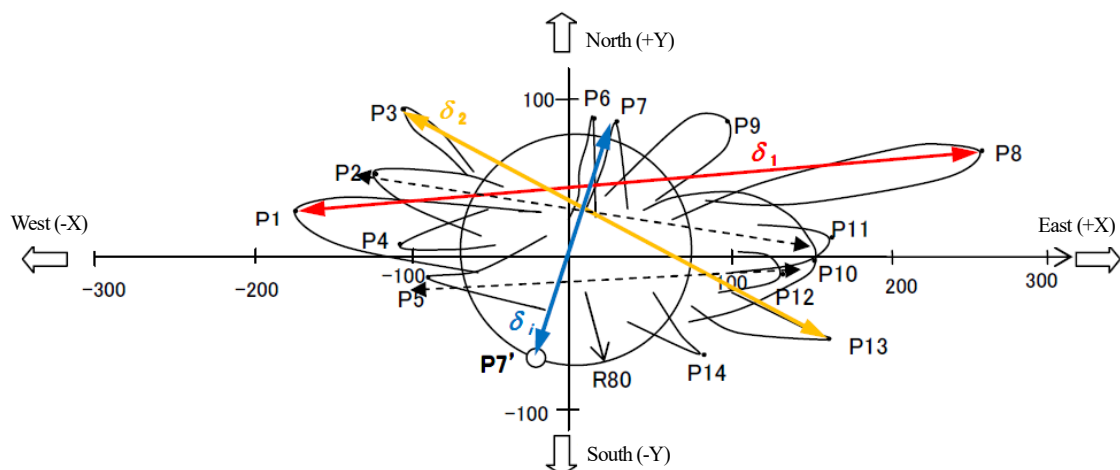
The method of evaluating low cycle fatigue of steel materials using Miner's law is well known, but this earthquake lasted a long time, and the marking plate was completely black within a radius of 80 mm because the marking lines overlapped, so three tests were conducted to accurately consider the degree of fatigue in this area.

Appearance of scratch board No. 1

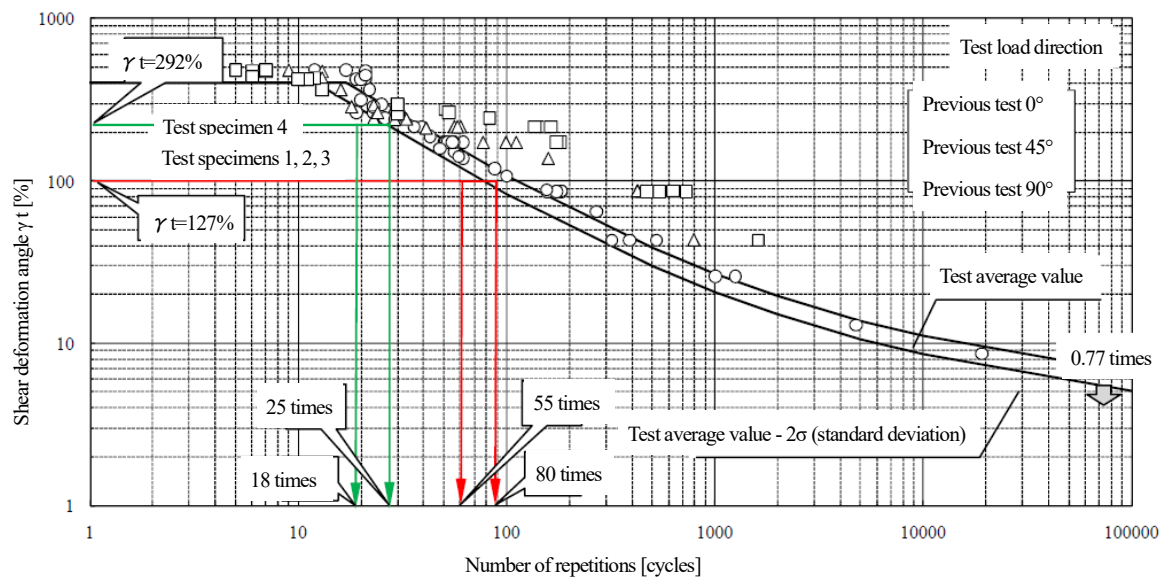
1) The degree of fatigue damage excluding the 80 mm radius part was in good agreement with the test results, so it could be said that the influence of the 80 mm radius part was small and that it was possible to adequately estimate the degree of fatigue damage by considering only large displacements.

In addition, in this test, the fatigue damage estimate was sufficiently safe even when taking into account the variation in the test results of the average value - 2σ .

2) Although the U-shaped damper suffered fatigue damage, it met the design performance requirements and could continue to be used.

Fatigue performance curve of U-shaped damper

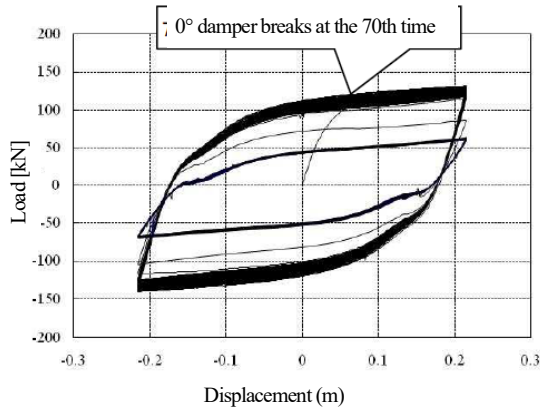
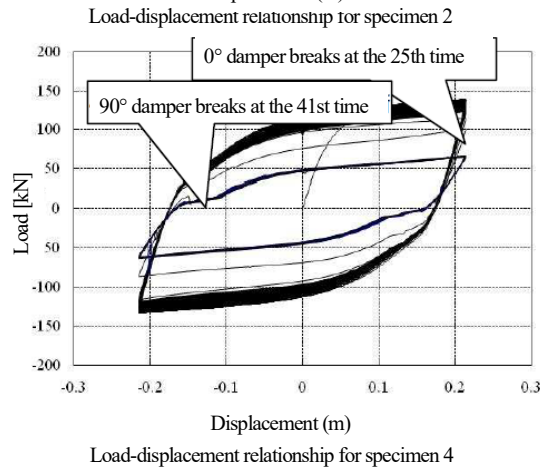
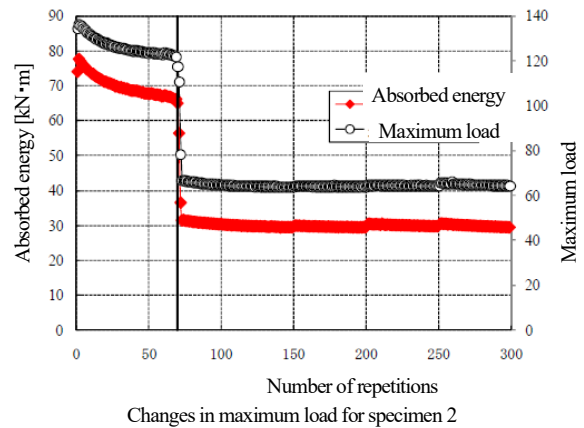
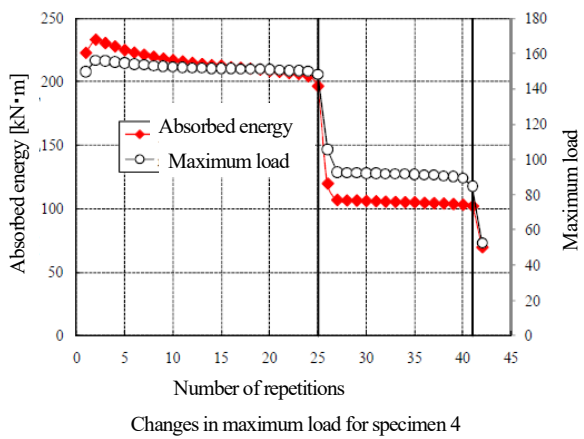
Average value	Average value - 2σ	Test result	Required value (Test (2) only)
Test (1)	76 times	51 times	①76 times ②70 times ③77 times	
Test (2)	24 times	15 times	④25 times	10 times

Top: specimen 2 with amplitude $\pm 213\text{mm}$ ($\gamma_t=127\%$), bottom: specimen 4 with amplitude $\pm 490\text{mm}$ ($\gamma_t=292\%$)
