Kumamoto Castle Keeps

1. Introduction

4. Reinforcement Overview

5. Seismic Reinforcement Plan

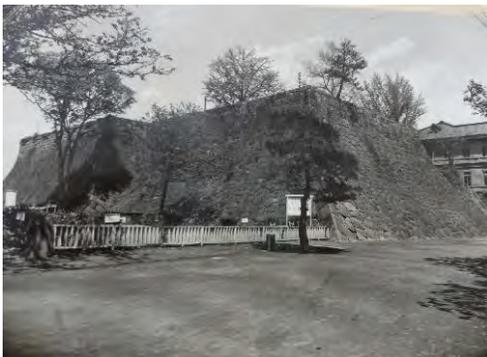
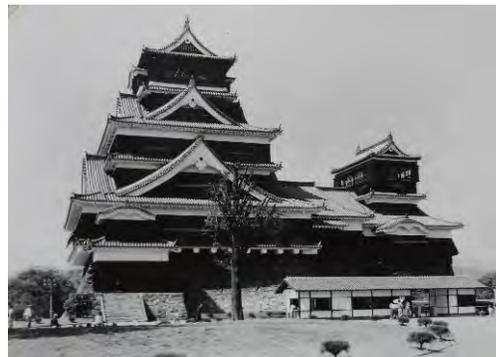
Fig.1-1 Panoramic photo of the Castle Keeps

Before construction begins in 1959

Upon completion in 1960

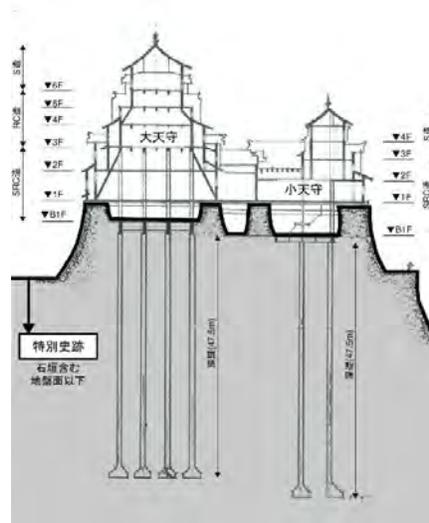
Fig.2-1 Cross-section of the castle keeps

Fig. 2-1 shows a cross-sectional view of the Castle Keeps.

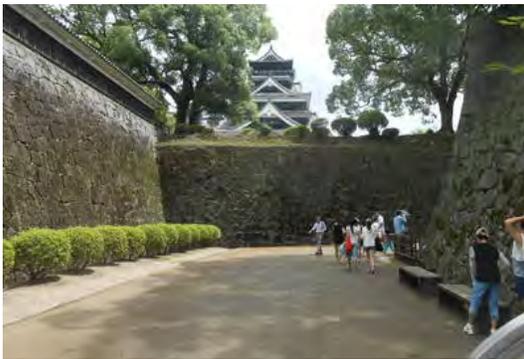
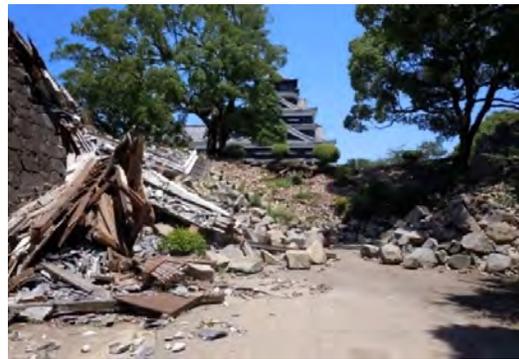
Fig.3-1 Photos of the site before and after the 2016 Kumamoto earthquake

The epicenter (seismic intensity 7) of the Kumamoto Earthquake was approximately 10 km away from Kumamoto Castle, which is located in the center of Kumamoto City (seismic intensity 6+). The earthquake caused extensive collapse of the buildings and stone walls throughout the castle grounds. Castle Keeps, which were restored in 1960 with a structural design that carefully considered the risks of earthquakes and foundation instability, sustained considerable damage, including the collapse of roof tiles and partial stone wall failure. However, the main structure remained in a condition that can be sufficiently repaired. Furthermore, the pile integrity test (IT test) documented in the “Castle Keeps Damage Investigation Report”¹⁾, indicated the high integrity of the piles, therefore, the deep foundations supporting Castle Keeps were deemed suitable for reuse.

Before the disaster

After the disaster

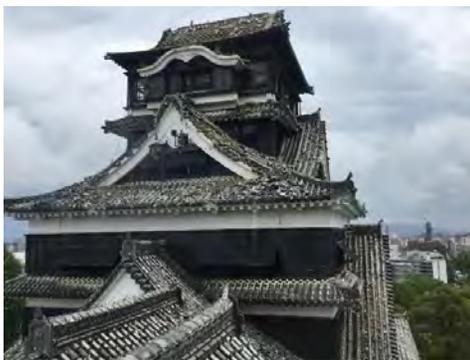
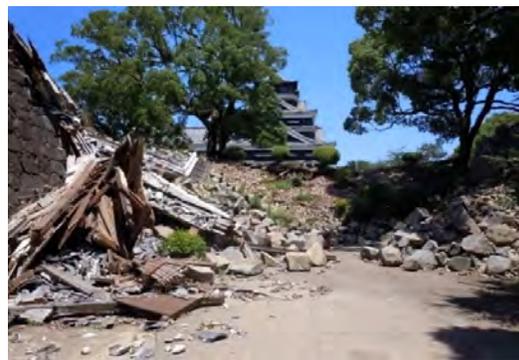
falling roof tiles

collapse of the stone wall

Fig.3-4 Photos of damage to the castle keeps

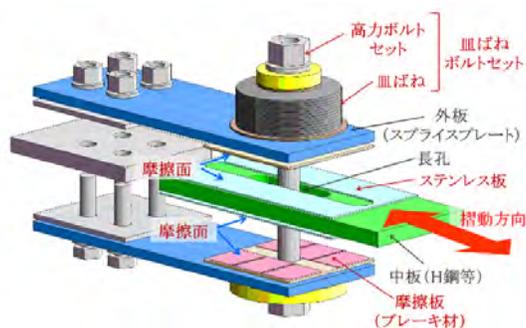
The Brake Damper is a seismic control device designed to reduce building response during earthquakes by converting building vibrational energy into frictional heat.

It comprises a pair of friction plates (brake material) and stainless-steel plates, which are clamped together within high-strength bolt joints.

Fig.4-1 The Brake Damper Configuration

The configuration of the Brake Damper is illustrated in Fig.4-1.

It is capable of achieving a ductility index (F value) equivalent to that of conventional steel frame bracing reinforcement. For this project, a ductility index of $F = 2.0$ was adopted.

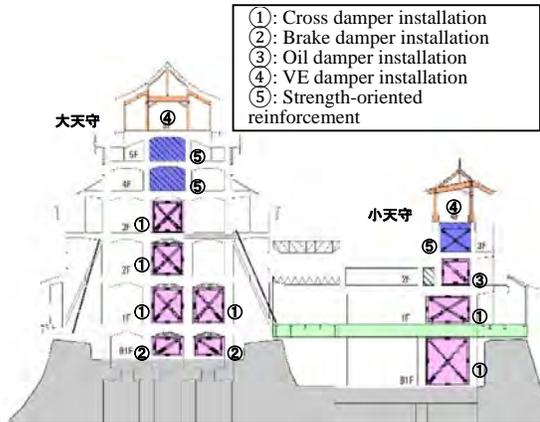
Fig.5-1 Structural reinforcement plan
(entire building)

This paper primarily reports on the details of seismic control reinforcement. Explanations regarding strength-oriented reinforcement and other supplementary measures applied are omitted. Fig.5-1 illustrates the post-reinforcement framing diagram, and Fig.5-2 illustrates the structural perspective view.

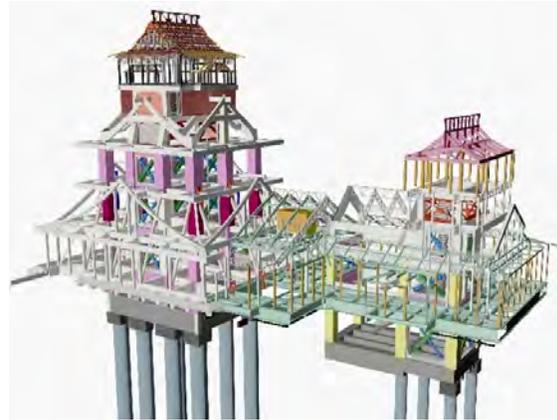
Fig.5-2 Structural perspective view after reinforcement
(entire building)

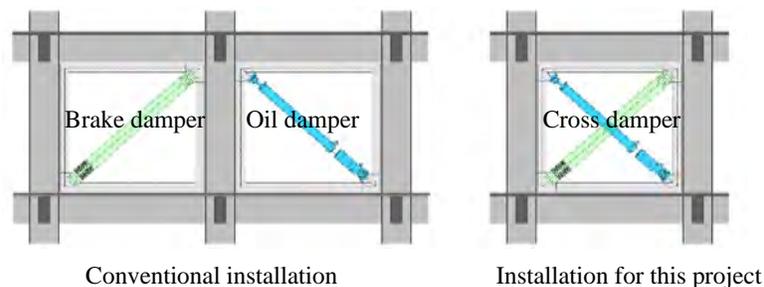
On the lower floors, Cross Damper®⁵⁾, which combines Brake Dampers and Oil Dampers in a crossed configuration on a single structural frame, was employed to reduce the number of reinforced frames and enhance circulation within the exhibition space.

Fig.5-3 Overview of cross dampers

Fig. 5-3 presents an overview of the Cross Damper, Fig. 5-4 illustrates its plan layout, and Fig. 5-5 shows the structural perspective.

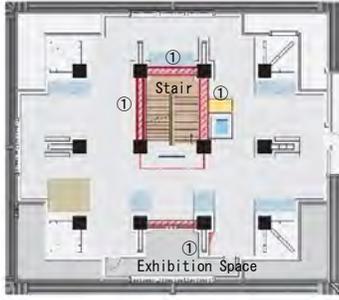
① : Position of Cross damper

Fig.5-4 Floor plan
(2nd floor of the main keep)

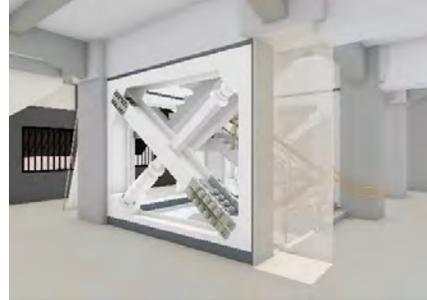
Cross dampers are installed
inside the partition wall of stairwell

Fig.5-5 Cross damper structure perspective
(2nd floor of the main keep)

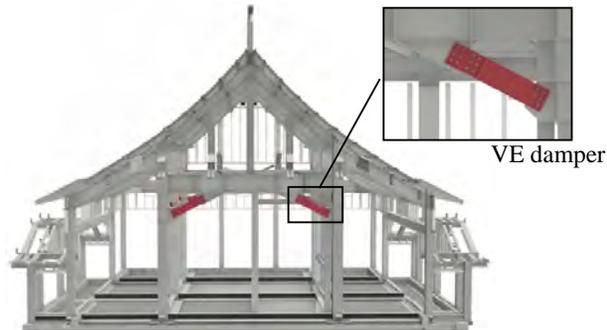
On the top floor, VE dampers were installed in a strut configuration within the interior finish of the dropped wall, contributing to the creation of an open and unobstructed observation floor by keeping the dampers out of sight. VE dampers absorb seismic energy through the shear deformation of high-damping rubber layers, which are tightly bonded between steel plates and have a thickness of 3 mm. Fig. 5-6 presents the structural perspective, while Fig. 5-7 illustrates the configuration of the VE damper.

Fig.5-6 Structural perspective (top floor)

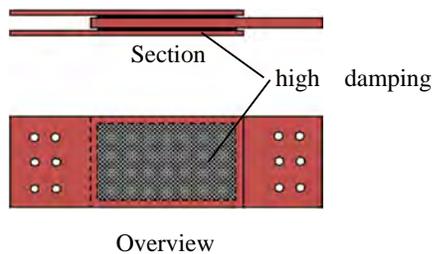
Fig.5-7 VE damper configuration

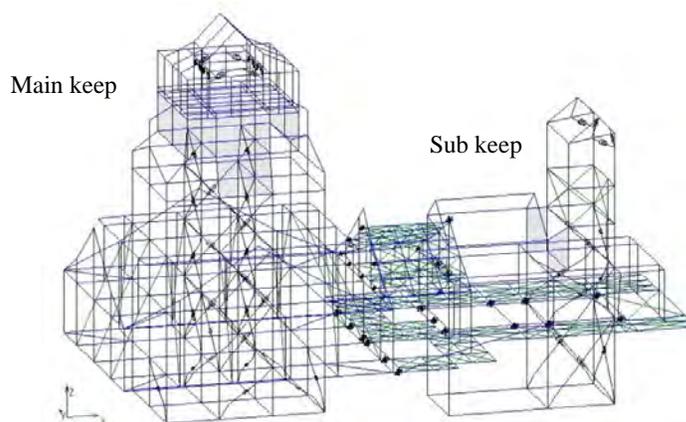
An elasto-plastic time history response analysis was performed on the superstructure using a three-dimensional frame element model (Fig.6-1) in which the main structural members were modeled as line elements. Regarding the modeling of each structural member, the ends of columns and beams were modeled using the MS model; the frictional components of Brake Dampers were modeled using a fully elasto-plastic bilinear model; oil dampers were modeled using a Maxwell model that accounts for axial stiffness; and VE dampers were modeled using a Voigt model, in accordance with the method described in Reference ⁶⁾.

Internal viscous damping proportional to instantaneous stiffness was assigned to each structural member. For existing RC and SRC members, a damping coefficient of 5% was applied, considering the enhanced damping effects expected due to factors such as cracking. In contrast, a damping coefficient of 2% was assigned to newly constructed steel-framed members, including the top floor.

Fig.6-1 Analytical model of superstructure

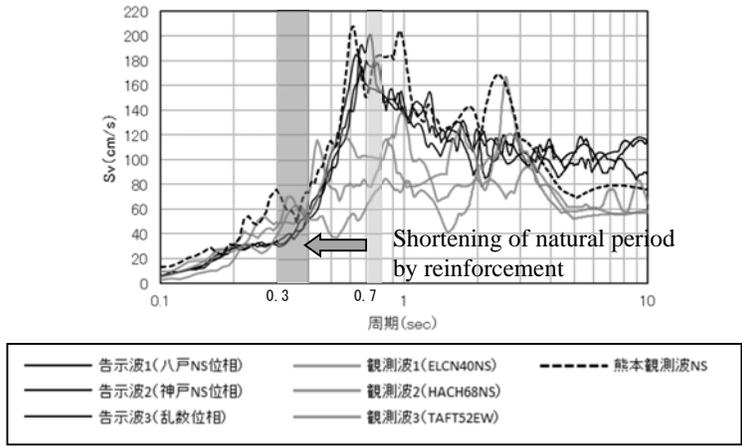
In the pseudo-velocity response spectrum (Fig.6-2), the predominant period is observed around 0.7 seconds. This corresponds to the fundamental natural period of the structure prior to reinforcement.

Due to the increase in overall structural stiffness resulting from seismic reinforcement, the fundamental natural period is expected to shorten to approximately 0.3–0.4 seconds, which is anticipated to reduce the input energy.

Fig.6-2 Pseudo-velocity response spectrum of adopted seismic motion (h=0.05)

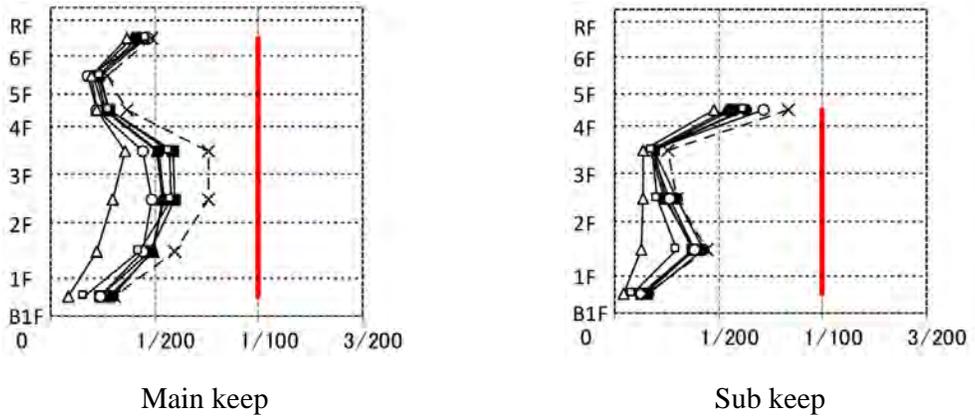
It was confirmed that the maximum inter-story drift angle during Level 2 seismic motion (Fig.6-3) was less than 1/100, which satisfied the design criteria.

Fig.6-3 Maximum inter-story drift angle (Level 2 earthquake in the Y direction)

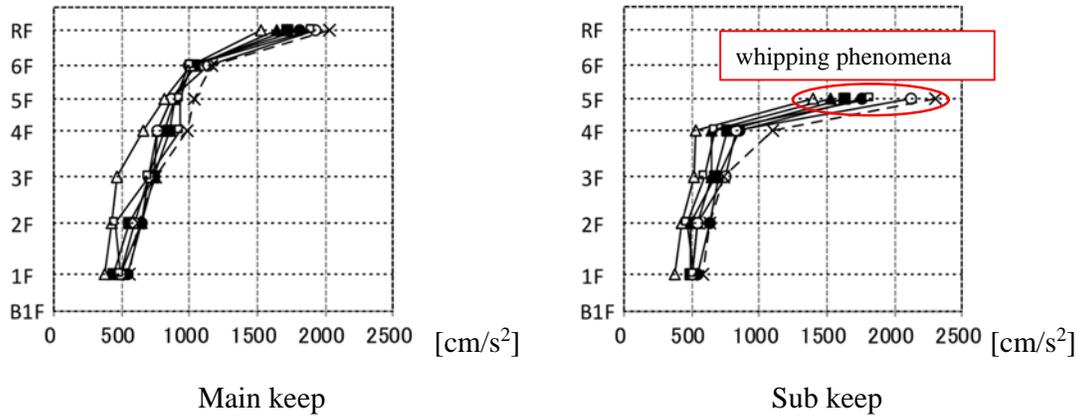
The maximum response acceleration results (Fig.6-4) indicate that a whipping phenomenon can be observed on the top floor of the steel structure.

This is attributed to the change in structural type and is consistent with the observed damage caused by falling roof tiles.

Fig.6-4 maximum response acceleration
(Level 2 earthquake in the Y direction)

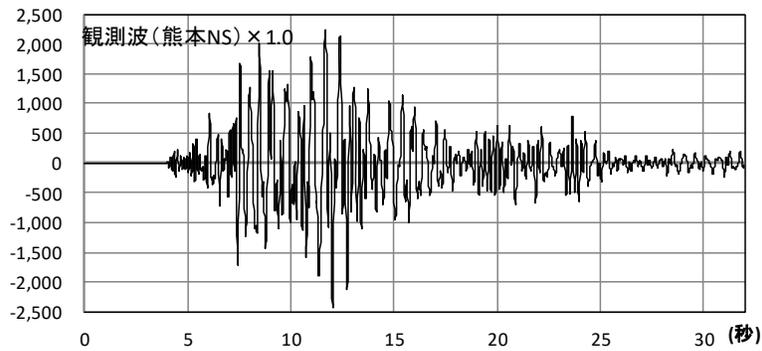
Fig.6-5 time history of response acceleration on the top floor of the small keep
(Level 2 earthquake in the Y direction)

In Section 8, “Performance Verification Test for Roof Tile Fall Prevention Measures,” the response acceleration waveform of the top floor (Fig.6-5) was utilized.

Prior to on-site installation, a full-scale test specimen was constructed on a three-dimensional shaking table capable of simultaneous excitation in three directions, and a performance verification test of the tile fall prevention measures was conducted. The response acceleration waveform of the top floor, shown in Fig. 8-2, was also used for the excitation input.

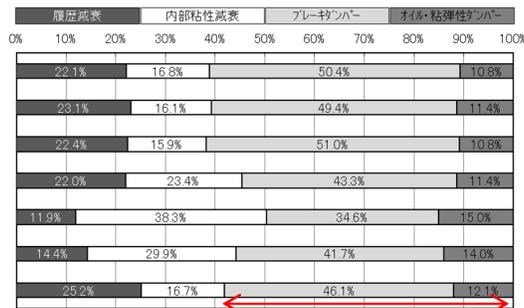
The effectiveness of the seismic control elements was evaluated by calculating the amount of energy absorbed by each element relative to the input energy during a Level 2 earthquake. It was confirmed that the seismic dampers absorbed approximately 50 to 60% of the input energy, significantly reducing the amount of energy absorbed by the main structure. (Fig.6-6)

50-60% absorbed by seismic dampers

Fig.6-6 Earthquake energy absorption distribution ratio
by damping element (Y direction)

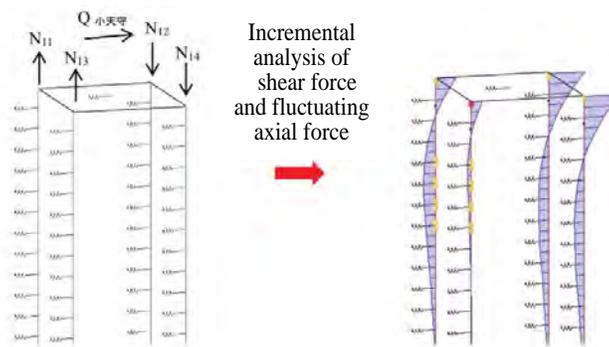
The deep foundation of this building contains a small amount of reinforcing bars and has a length-to-diameter ratio exceeding 10. Therefore, following the pile design methodology, it was modeled using line elements combined with ground springs (Fig.6-7), and an elasto-plastic pushover analysis was performed. The maximum seismic story shear force of the superstructure and the fluctuating axial forces of the columns were applied as incrementally increasing loads at the top of the deep foundation.

As the foundation is classified as a deep foundation, only shear and axial forces were considered in the analysis, and the absence of brittle failure was confirmed.

Fig.6-7 Analytical model of the foundation structure (small keep)

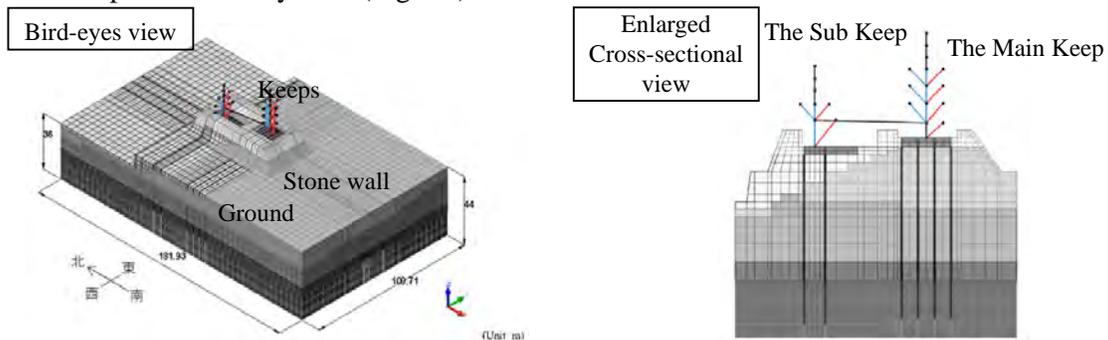
A three-dimensional coupled seismic response analysis (superstructure-deep foundation-ground model), which considered the ground conditions resulting from the unique embankment shape of castle structure characteristic, was also conducted. It was confirmed that the dynamic maximum response shear force of the deep foundation—caused by inertial forces from the superstructure and kinematic soil deformation—was approximately half of that obtained from the static pushover analysis. (Fig.6-8)

Fig.6-8 Three-dimensional coupled seismic response analysis model

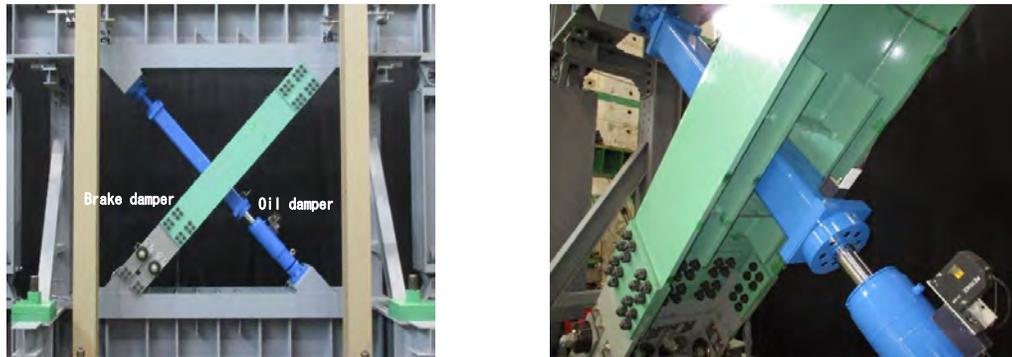
In order to verify the structural performance of the Cross Damper®, full-scale dynamic loading tests were conducted using a loading frame as shown in Fig. 7-1.⁷⁾

the penetration part of the damper

Fig.7-1 Cross damper test specimen (full view)

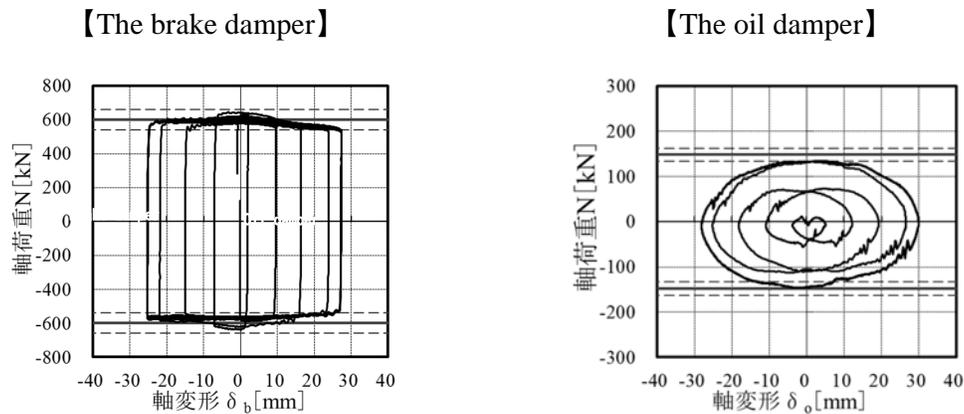
Fig. 7-2 illustrates the load–displacement (axial deformation) relationship of each seismic damper under sinusoidal wave loading conditions ($T = 2.0$ sec, $\delta = \pm 40$ mm).

The solid line represents the calculated maximum damping force, while the dashed lines indicate the range of loads within $\pm 10\%$ of that value.

The Brake Damper exhibits perfectly elasto-plastic hysteresis behavior, forming a rectangular hysteresis loop that efficiently absorbs seismic energy.

Due to its velocity-dependent characteristics, the Oil Damper generates maximum damping force within a narrow range of axial deformation near the origin.

Fig.7-2 Load-displacement (axial deformation) relationship of each seismic damper

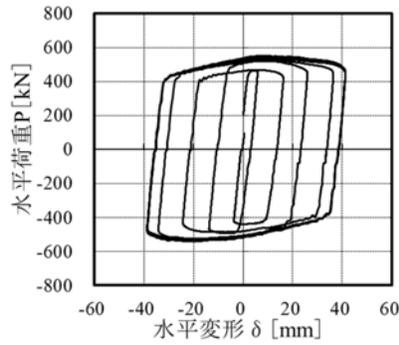
Fig. 7-3 presents the horizontal load–displacement relationship of the Cross Damper, based on the combined results described above.

Fig.7-3 Load-displacement (horizontal) relationship of cross dampers

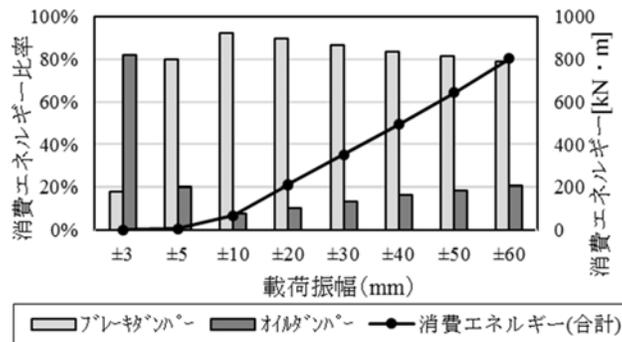
Fig. 7-4 illustrates the variation in energy absorption ratios of each seismic damper with respect to loading amplitude.

The Oil Damper begins to absorb energy even at very small amplitudes (± 3 mm).

For amplitudes of ± 10 mm or greater, the Brake Damper predominantly contributes to energy absorption. However, as the amplitude increases, the energy absorption ratio of the Oil Damper also rises, resulting in an overall increase in the total energy absorption of the Cross Damper.

Fig.7-4 Changes in the energy absorption ratio of each seismic damper

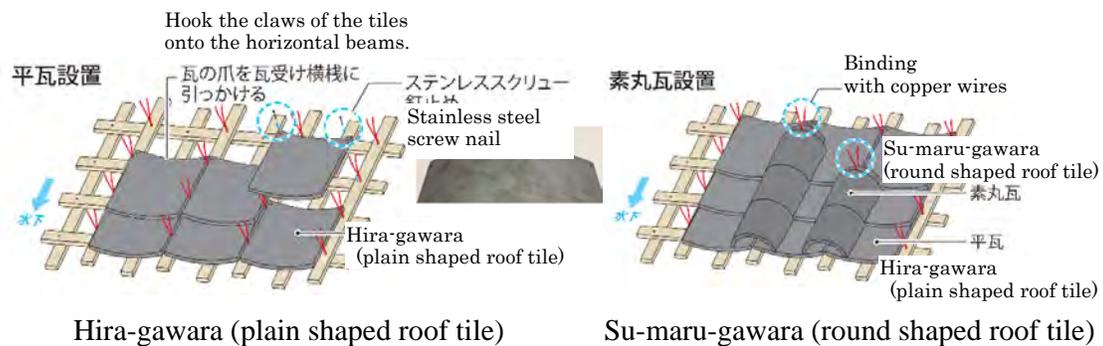
For the restoration of the tiled roof, a dry construction method was adopted, in which each tile was individually fixed to the underlying wooden battens as a measure to prevent tile fall (Fig. 8-1).

Hira-gawara (plain shaped roof tile)

Su-maru-gawara (round shaped roof tile)

Fig.8-1: Overview of measures to prevent roof tiles from falling

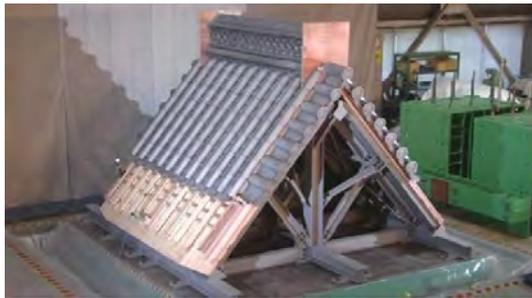
Ultimately, the input was increased to a horizontal acceleration of 3G, which is the maximum capacity of the shaking table, and no tiles fell, confirming the effectiveness of the measures.

Fig.8-2 Test specimen for measures to prevent roof tiles from falling (full view)

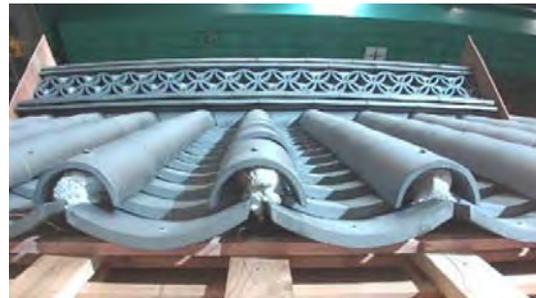
Fig.8-3 Test specimen for measures to prevent roof tiles from falling (roof tile installation section)
