Keiju Medical Center "The Miracle of Noto"

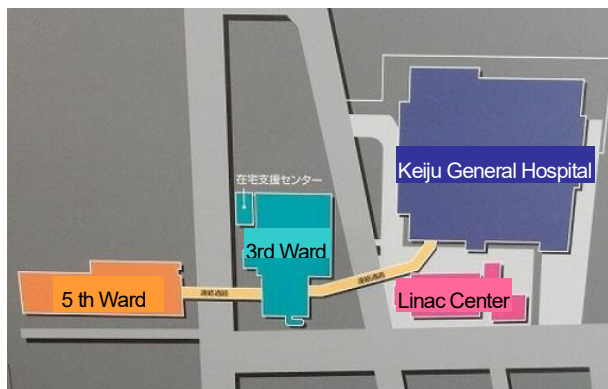
Photo 1: Layout

As shown in Photo 1, Keiju General Hospital is composed of four buildings: the main building with seismically isolated structure, and the 3rd Ward, 5th Ward, and the Linear Accelerator Center, which are all earthquake-resistant buildings. The main building and 3rd Ward, the main building and the Linear Accelerator Center, and the 3rd Ward and 5th Ward are connected by corridors equipped with vibration control devices.

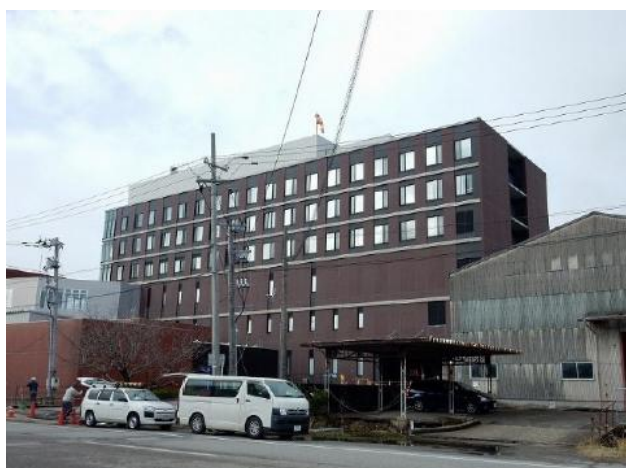
Photo 2: Main building (seismically-isolated building)

The seven-story reinforced concrete seismically-isolated main building, completed in 2013, shown in Photo 2, has a total of 49 natural rubber and high-damping rubber bearings installed in the base isolation layer.

The primary natural periods during L1 and L2 earthquakes are approximately 4.0 and 4.3 seconds, respectively, and the maximum displacement during L2 earthquake is approximately 410 mm, with a generous design clearance of 600 mm. As a countermeasure against tsunamis, the floors were designed to be raised 1.5 m, with the electrical room and server room located on the upper floors, and lattice-patterned ground improvement work was also carried out as a countermeasure against liquefaction.

During the Noto Peninsula earthquake, the seismically-isolated main building suffered no damage to the building or facilities, and no medical equipment toppled or fallen.
