Ishinomaki Red Cross Hospital:

The hospital that sparked the spread of seismically-isolated structures.

•Ishinomaki Red Cross Hospital's seismically-isolated structure allows it to function as a disaster base.

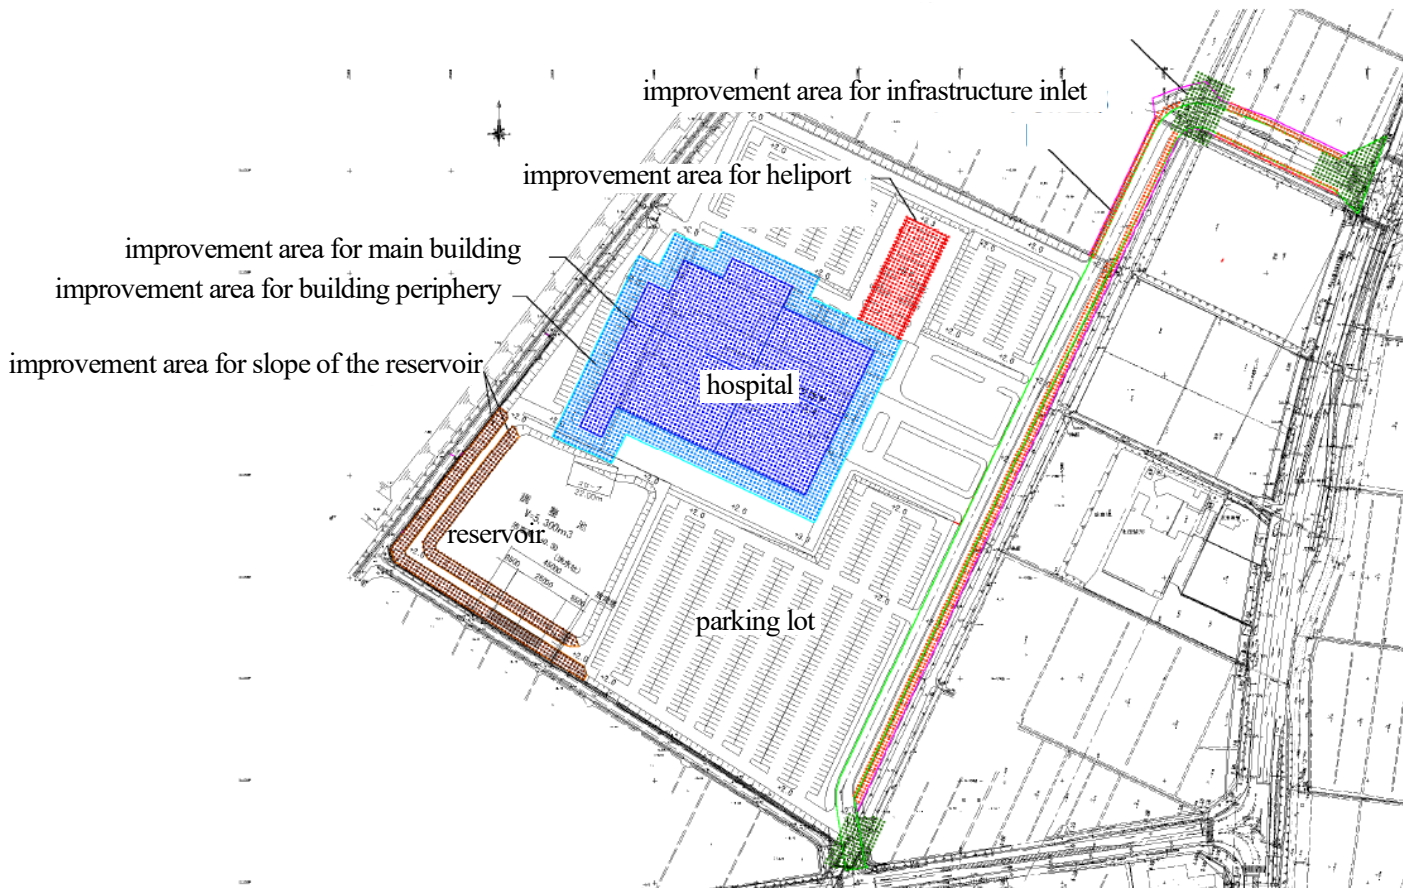
Layout of the ground improvement area

As shown in the figure below, the dynamic compaction sand pile method was used for ground improvement in areas that need to maintain functionality in the event of a disaster, such as the main building, medical gas building, infrastructure intake section, and heliport, and as a result, the soil was able to be maintained without liquefaction.

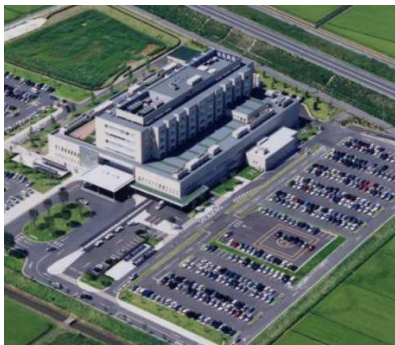
Heliport and large eaves in front of the entrance

The heliport also had ground improvement work done, so it did not liquefy. Many lives were saved.

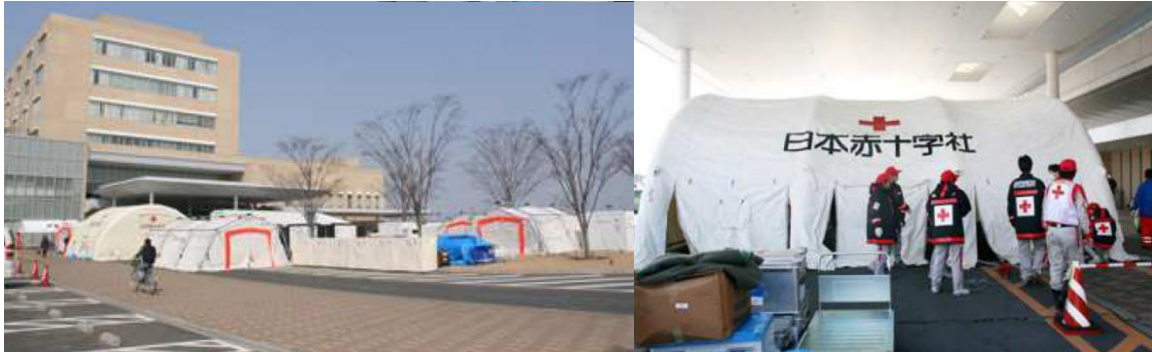
Eaves in front of the entrance and Tents

A large eaves was placed at the entrance in preparation for storms and snow, and it effectively served as a temporary rain shelter for disaster victims and medical equipment.

Many tents were set up using this large eaves as an outside base, enabling emergency medical services to function.

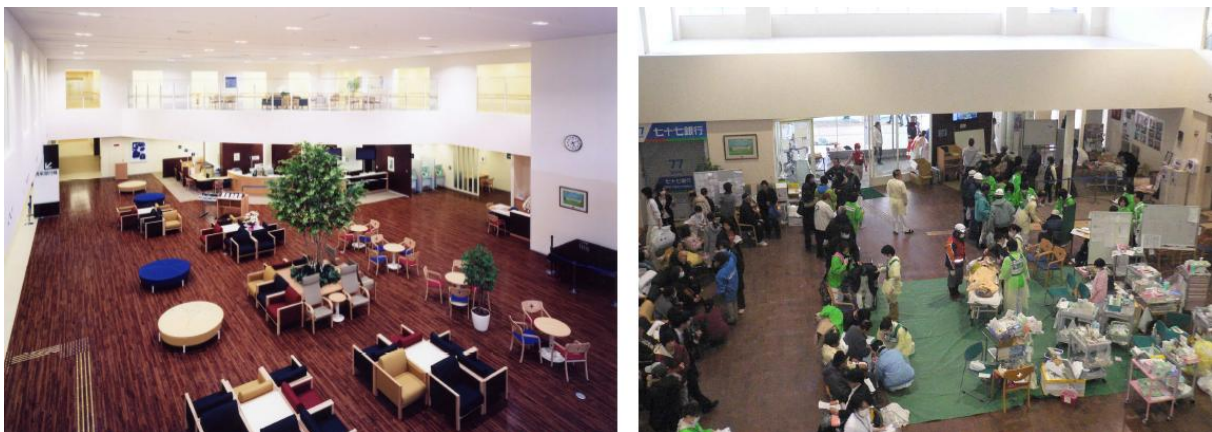
The first floor entrance hall (Red Cross Plaza) under normal conditions (left) and after the earthquake (right)

The first floor entrance hall was made up of movable furniture so that it could function as an activity base in the event of a large-scale disaster. In the event of an earthquake, as envisaged in the design, chairs and other furniture were removed to create an open space in the waiting room, allowing the hospital to accept patients with minor injuries and provided simple emergency medical care.

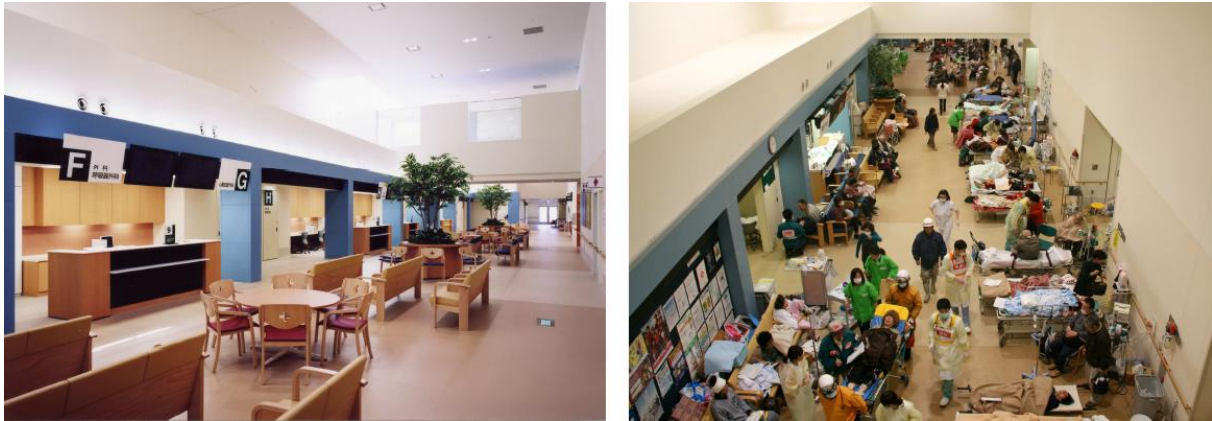
The first floor outpatient waiting room under normal circumstances (left) and after the earthquake (right)

The outpatient waiting room adjacent to the first floor entrance hall also functioned as a base of operations in the event of a large-scale disaster. In particular, many spare medical gas outlets were installed on the walls of the outpatient waiting room, so that it could handle even slightly seriously injured patients. During the earthquake, emergency medical treatment could be given to patients with moderate injuries.

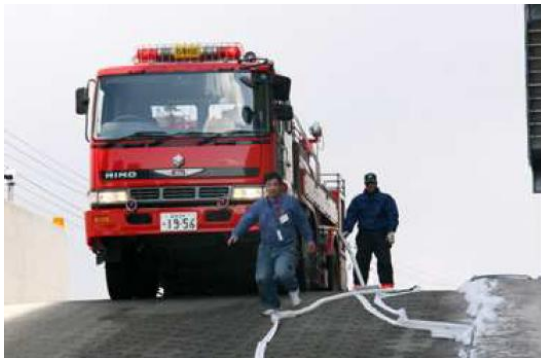
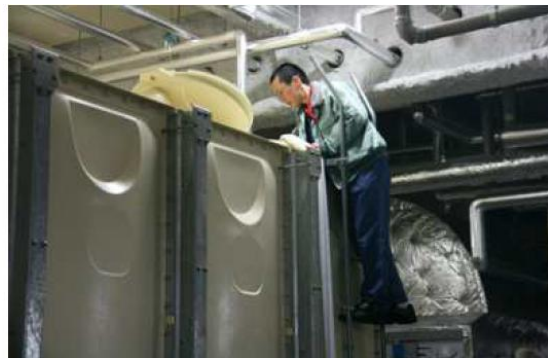
Water tanker (left) and water tank on the first basement floor (right)

Under government guidance, only 0.5 days' worth of drinking water could be stored. Therefore, the hospital was managing the emergency by sending water from a water truck to the drinking water storage on the first basement floor.

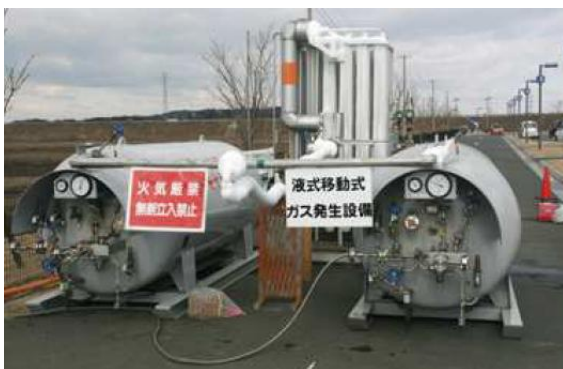
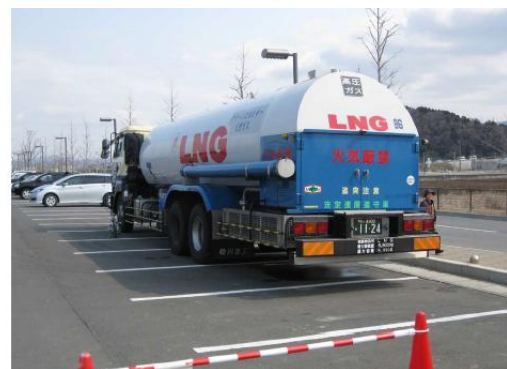
Temporary gas pressure transmission equipment (left) and tanker truck (right)

The medium pressure gas base along the coast was unable to deliver due to the tsunami. Therefore, gas pressure transmission equipment was installed on the site, and gas was sent from tank trucks to the hospital through this equipment.

This was also possible because the liquefaction countermeasures of the infrastructure on the site and the seismic isolation structure meant that the piping inside the building was not damaged.
